KEY SITE ASSESSMENT DOLPHIN SQUARE

In each of the major Dacorum towns, we have selected a key site for a brief urban design assessment according to the urban design criteria. Dolphin Square represents an important experiment in the Tring town centre fabric which has both critical urban design strengths and weaknesses.

DACORUM URBAN DESIGN ASSESSMENT TRING JANUARY 2006

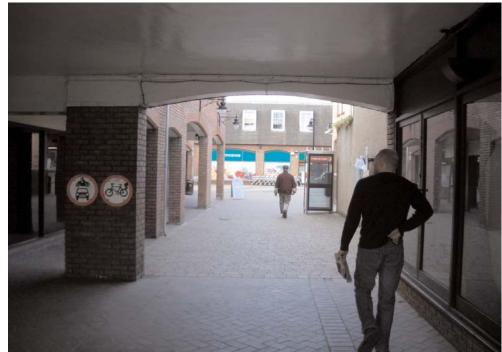
Poor use of greenery or planters leaves the courtyard feeling cold and isolated.

There is no use of planters or greenery in Dolphin Square, leaving it feeling isolated and cold.

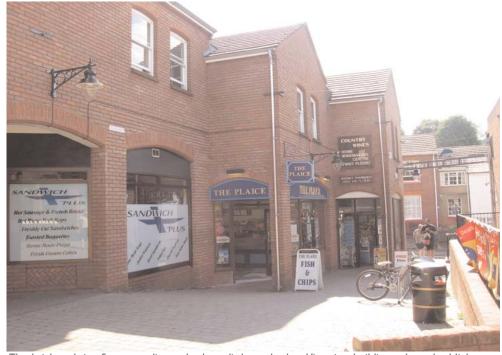
The brickwork is of poor quality and relates little to the late Victorian buildings along the High

The quality of brickwork is poor and relates little to the late Victorian buildings along the High Street.

The traditional use of streetscape elements (lights and wall-mounted lamps) clash with the poor-quality machine-made brickwork. This clash is worsened by the presence of CCTV cameras directly above the wall-mounted lamps.

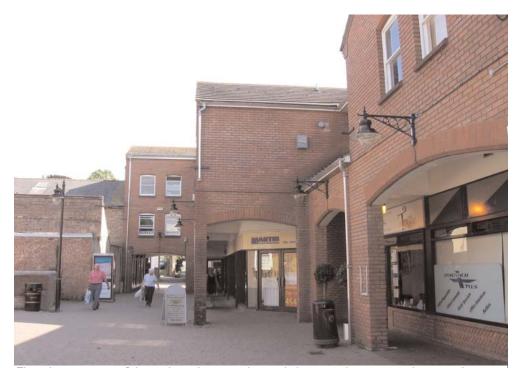
The adaptive re-use of the traditional courtyard morphology provides a new pedestriansed space and provides an active frontage for the shops.

Dolphin Square is an important adaptive re-use of the traditional courtyard morphology, developing a new pedestrianised space from the old service yard. It should also be noted that a new service courtyard on Frogmore Street has been developed to service Dolphin Square.

The shops within the courtyard have active frontages.

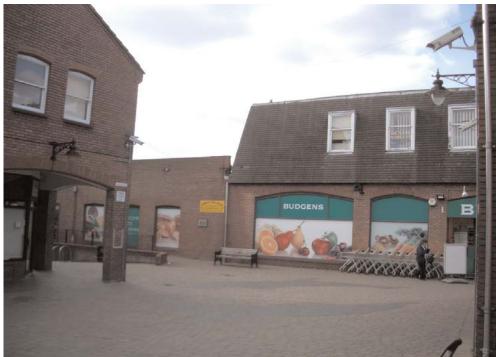
Dolphin Square comprises a mix of primary food shopping sources and specialist shops.

Dolphin Square provides primarily A1 shops, both primary food shopping sources and specialist shops.

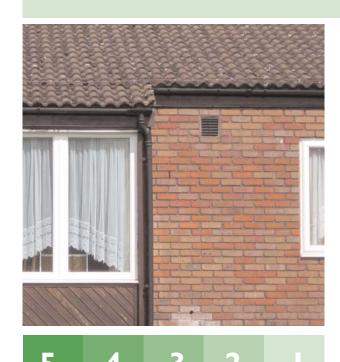
This image of a modern stretcher bond red brick house in Tring was considered 'average' by the majority of people. The words used to describe these materials reflected that people considered them ordinary, bland and unexceptional.

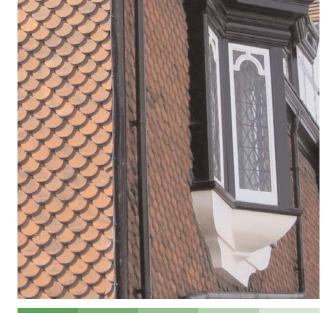
The materials in this image are a typical style for Tring. Scallop tile-hanging of clay tiles reflect the Rothschild tradition of the late Victorian era. Participants responded positively to these materials and eleven people gave this image a score of five or four. Only two people did not like the building materials. Words used to describe the materials ranged from 'elegant' and 'warm' to 'fussy' and 'fake'.

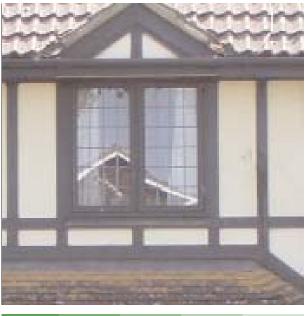
This image of a 1980s timber framed building in an imitation style received a mixed response at the consultation event. Many different words were used to describe the materials including 'vulgar', 'confusing' and 'sophisticated'.

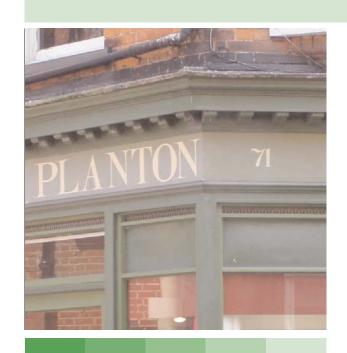
This traditional shopfront was relatively popular with no scores below three. Whilst some people considered the sign as 'classy' and 'tasteful' others felt that it was 'unremarkable'.

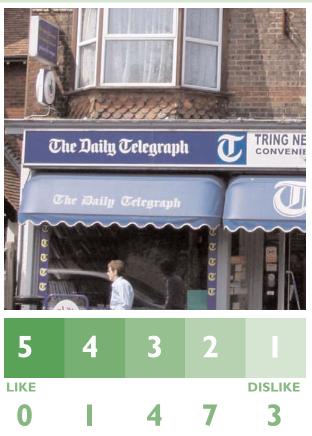
This newsagent's shop sign was most frequently given a score of two and the highest score was four. Adjectives used to describe the style of sign revealed that people considered the sign to be unexceptional. Some people felt that it was not suited to the character to Tring.

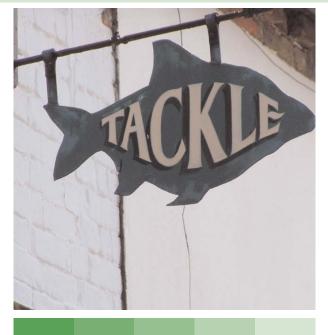
This unique shop sign was also popular with participants at the consultation event. The most common score for this sign were four and five. Many people enjoyed the unusual nature of the sign and the words used to describe it reflect this. A few adjectives revealed that some people considered the sign 'tacky'.

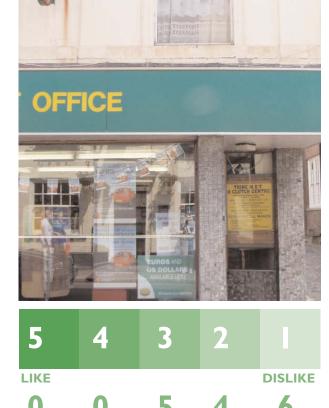
The Post Office sign was less popular and many people perceived it to be 'functional' and 'utilitarian' or 'ugly'. This perception was echoed in the scores that people gave the sign which ranged from three to one.

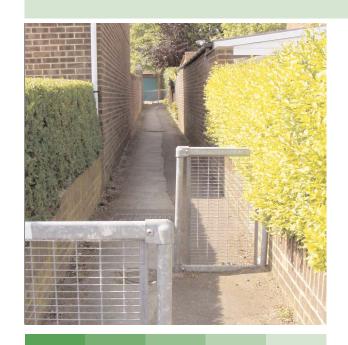
This footpath was perceived as functional and pleasant by some people whilst others felt it was dangerous and unsafe. This mixture of comments is reflected in the wide range of scores that people gave the image. Seven people gave the footpath a score of three or four and eight people gave it a score of two or one.

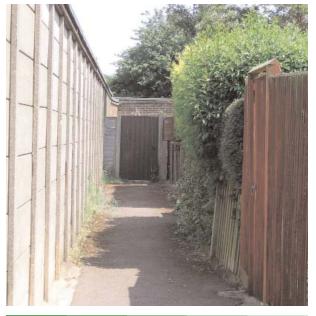
This footpath was very unpopular with all participants giving it a score of one or two. Many adjectives used to describe the area revealed that people considered it to be threatening, uninviting and unsafe.

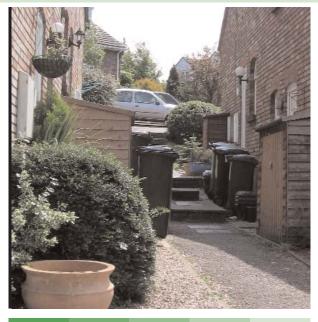
The footpath in this example was more popular and the majority of people gave it a score of five to three. A few people gave the footpath a score of one or two. The footpath was considered 'interesting' and 'neat' although some people felt that it was 'messy' and 'cluttered'.

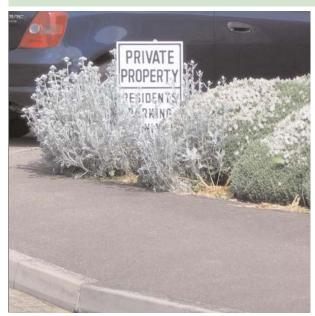
This boundary area was subject to a mixed response. Some people considered that the boundary was neat and safe whilst others felt that it was unnecessary and suburban.

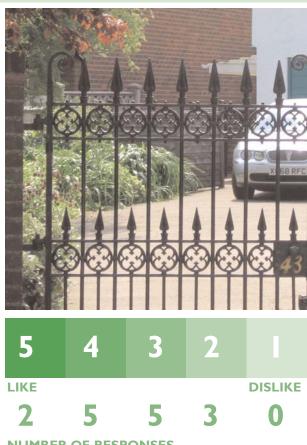
This residential boundary was most frequently given a score of three of four. Adjectives such as 'grand' and 'smart' were used by some to describe the boundary. Conversely, other people described the area as 'pretentious', 'forbidding' and 'twee'.

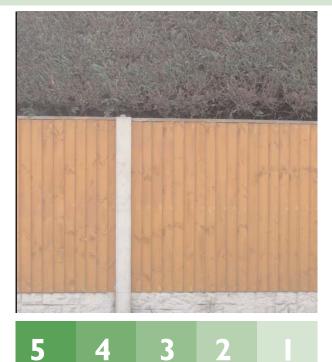
The fence in this photograph was generally less popular than other images and was most frequently given a score of two. Many people found the boundary ordinary, functional and uninspiring.

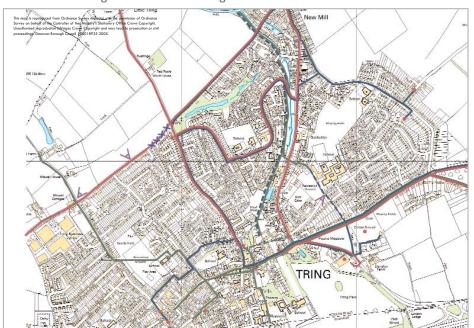
Group 1:The canal was a popular walking route in this group

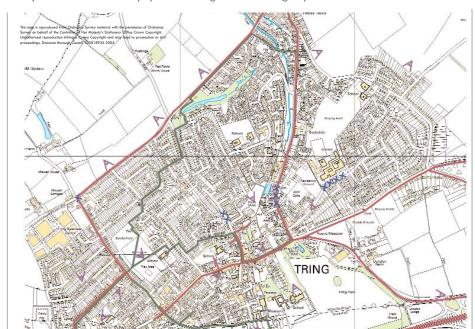
Group 3: Popular views include those from the outskirts of Tring over adjacent open space
